## Spurious 'Warning 07' / 'Battery Low' Messages on Driver Control Panel (DCP)

Version 01

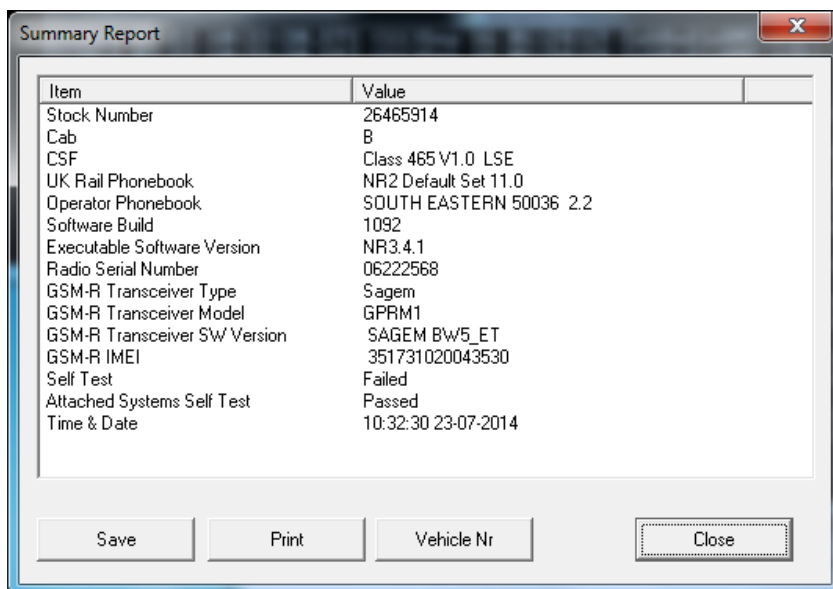
There have been reported incidents of spurious 'Warning 07' or 'Battery Low' messages being displayed on the Driver Control Panel (DCP). Investigations have identified that the problem is caused by running the GSM-R Portable Maintenance Unit (PMU) Summary report (see example below) whilst the DCP or (where fitted) the Uninterruptible Power Supply (UPS) is switched off.

If the PMU Summary report is run when the DCP is switched off via the Drivers Master Switch then the radio self test will report as failed and the next time the DCP is switched on a 'Warning 07' message will be displayed on the DCP and a Warning 07 – Secondary Control Panel Fault will be reported in the cab mobile fault log.

Additionally on UPS fitted vehicles, if the PMU Summary report is run when the UPS is switched off then the radio self test will report as failed and the next time the DCP is switched on a 'Battery Low' message will be displayed on the DCP.

To avoid any spurious 'Warning 07' or 'Battery Low' messages being displayed on the DCP please ensure that the DCP and (where fitted) the UPS are both switched on before running the PMU Summary report.

If a spurious 'Warning 07' or 'Battery Low' message is displayed on the DCP then this can be cleared in one of three ways:

1. Turn off the DCP by holding down the REG / DE-REG key on the DCP for more than two seconds and then turn the DCP back on
2. Insert and remove Drivers key
3. Power cycle the cab mobile
